Mechanical behaviour of tools for shearing Ultra High-Strength Steels: influence of the microstructure on fracture and fatigue micro-mechanisms of tool steels and evaluation of micro-mechanical damage in tools

A Thesis submitted for the degree of Doctor in the Universitat Politècnica de Catalunya,
Fundació CTM Centre Tecnològic.

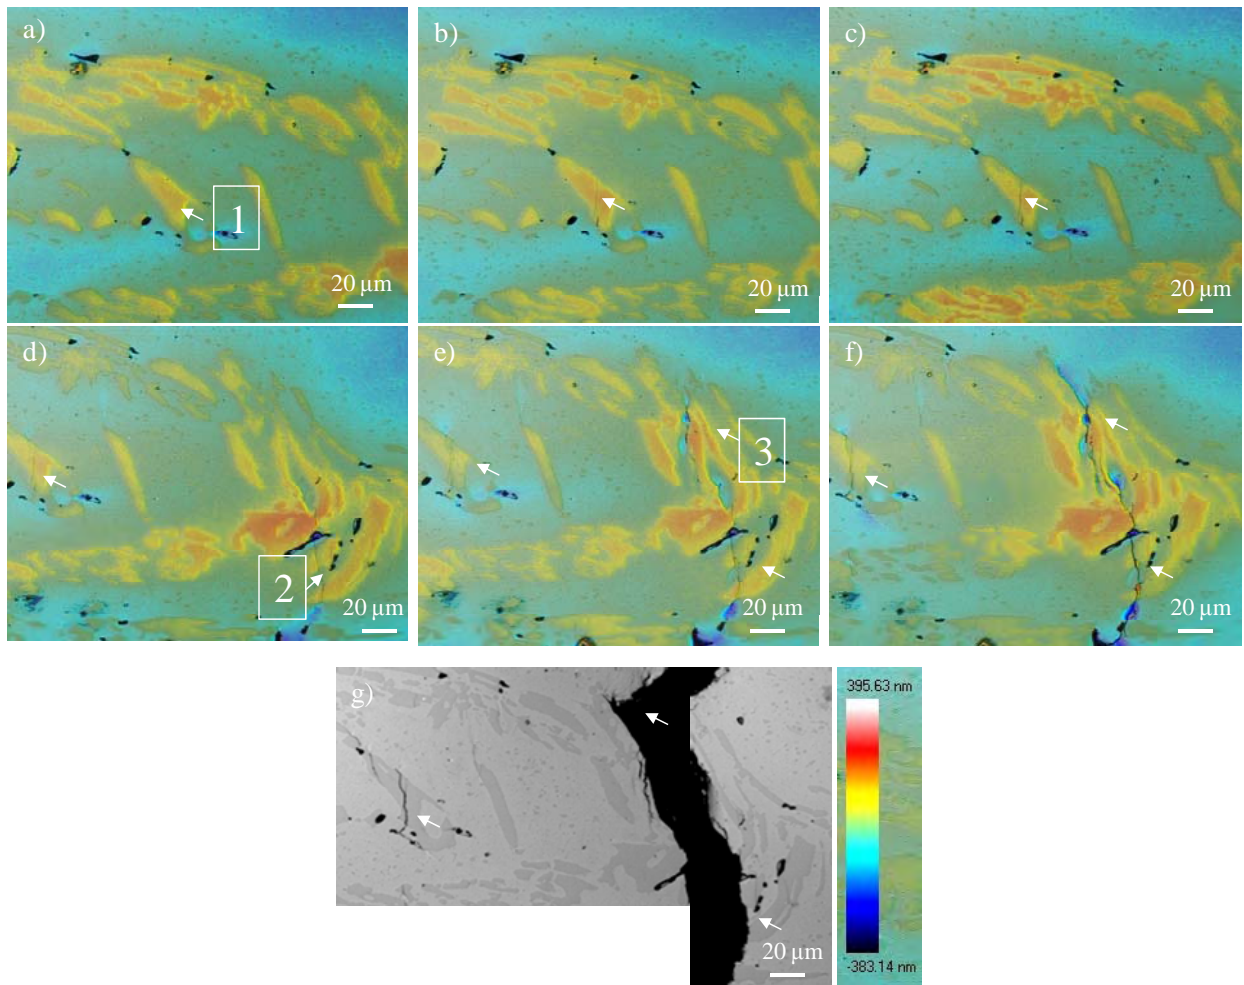
Figure 3.2.16 Evolution of cracks at the surface of the sample 1.2379 D2 at the applied stresses of : a) 900 MPa; b) 1100 MPa; c) 1400 MPa; d) 1700 MPa; e) 2000 MPa; f) 2400 MPa and g) fracture at 2364 MPa

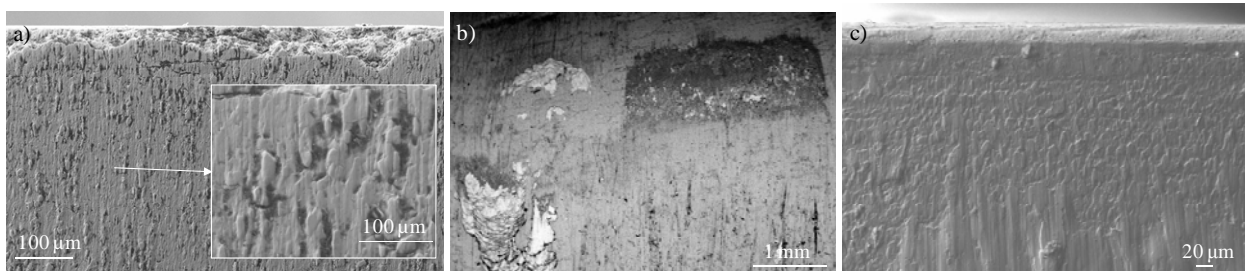
Figure 3.3.5 Wear related phenomena in tools: a) abrasive wear; b) adhesive wear; c) severe wear (abrasive + adhesive)

- Abrasive wear: when abrasive particles, such as oxides, contact to the tools (that is especially important in non-coated sheets) (Figure 3.3.5 a)).
- Adhesive wear: when the sheet material (usually coated) adheres to the tool surface. Adhesive wear can lead to local decreases of clearance, which increases the stresses in tools and accelerates fracture (Figure 3.3.5 b)).
- Severe wear (adhesive + abrasive): it takes place when contact pressures at the tools surface are extremely high (Figure 3.3.5 c)).

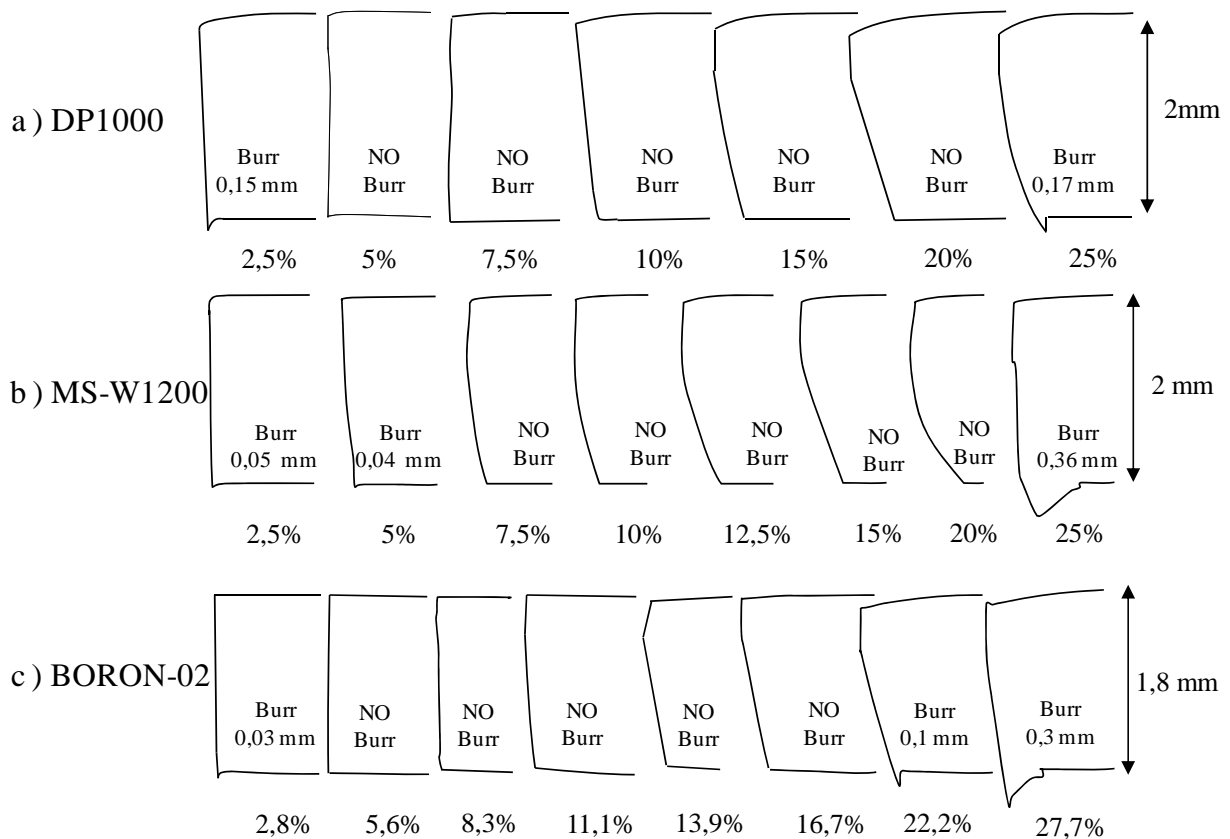
Figure 3.3.90 Schema of the punched sheet edge morphology of: a) DP1000 2 mm thick; b) MS-W1200 2 mm thick and c) BORON-02 1,8 mm thick for clearances between 2,5 % and 27,7 %
