## Chapter 6

### 6 Seismic Vulnerability in Mérida

#### 6.1 Introduction

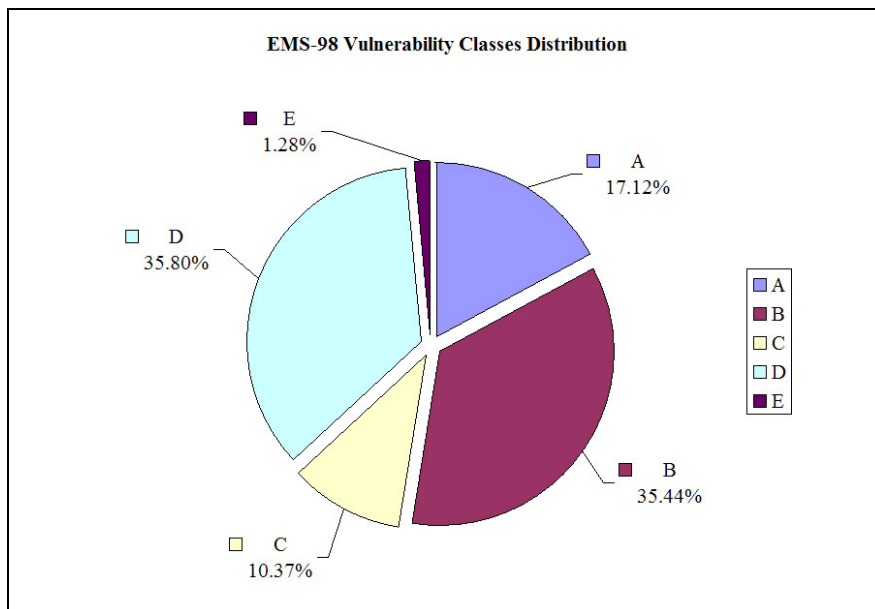
Figure 6.1: EMS-98 Vulnerability Classes distribution.

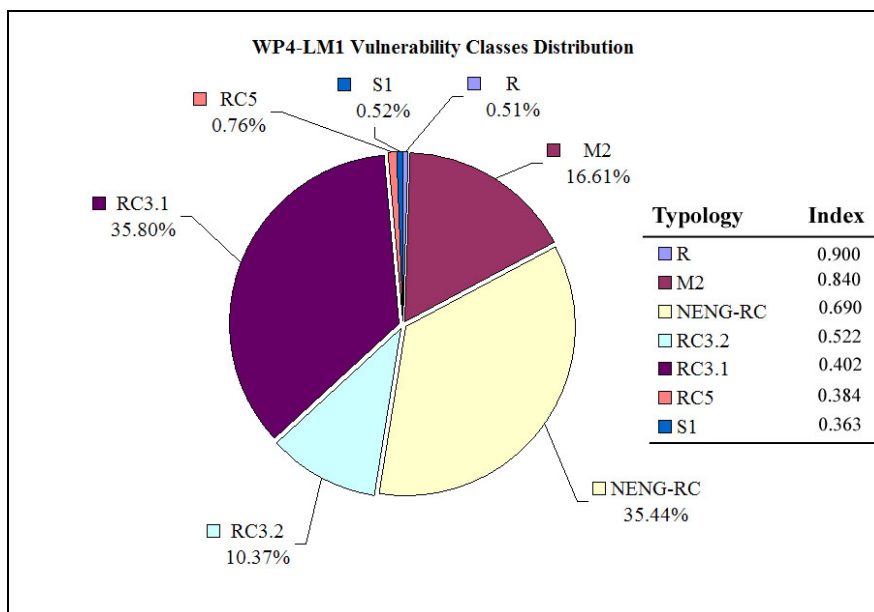
**Figure 6.2: LM1 Vulnerability Classes distribution.**

The damage grades distribution (DG0 to DG5) for the considered typologies (seven, in total) as a percentage of the whole building stock by intensities is shown in Figure 6.5. From the observation of the different charts, it is evident that the most damaged vulnerability class (in percentage of the total number of buildings) is the one corresponding to the NENG-RC typology, which along with typology RC3.1 constitute the two most common ones in Mérida's survey (see Figure 6.2).

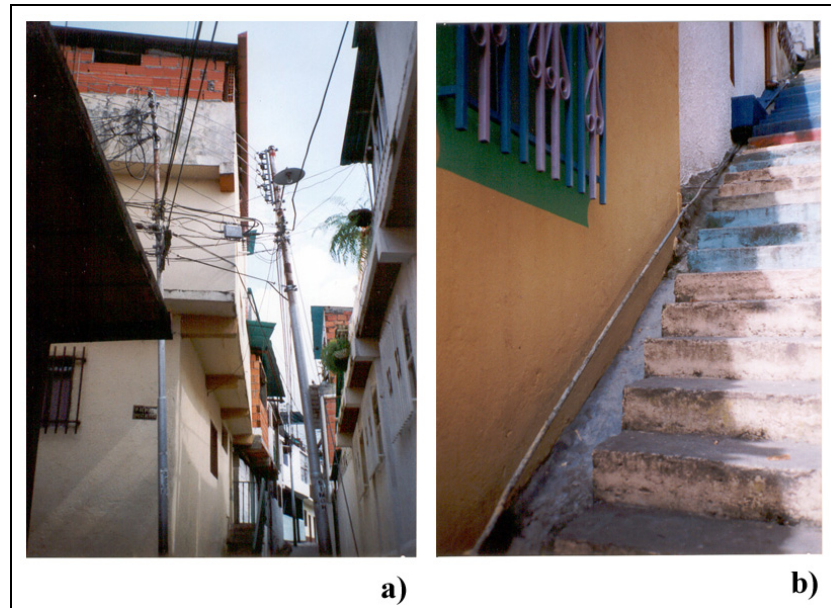
**Picture 1: Electricity and water supply in La Milagrosa Barrio.**

- Electricity and telephone infrastructure: the supply of both services is performed by aerial cables supported by posts, no subterranean telephone or electric lines exist. Telephone service is only available in the sectors limiting with the Los Próceres Avenue, i.e. the La Milagrosa, Miranda and Los Molinos Sectors. The uncontrolled growth of informal settlements such as La Milagrosa barrio has produced an increment in the number of electric lines in the posts and the consequent entanglement of them (see Picture 1a), with hazardous line trajectories in front of windows and balconies and also at roof edges. These characteristics are observed in all sectors of La Milagrosa.

- Sewage System: excretal waters are all embedded in the streets (with manholes) in the lower sectors; and under the stairways and paths in the upper sector (Cristo Rey), the latter without maintenance reach, unless a local destruction of stairways and paths is performed.

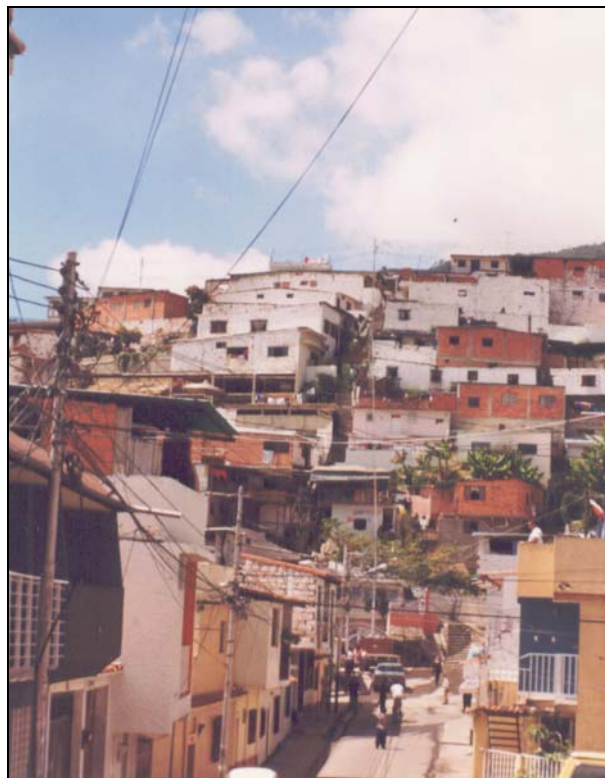
**Picture 2: Buildings in flat and sloped sites.**

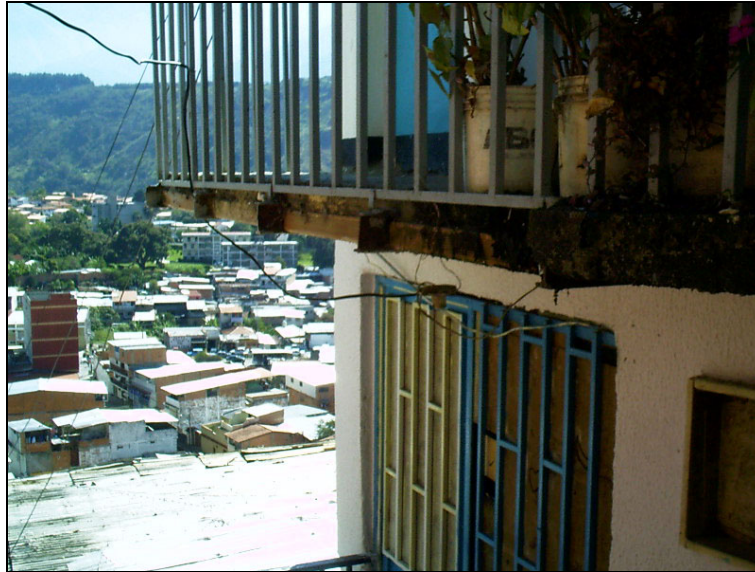
**Picture 3: Detail of a slab (balcony in a sloped site building).**

The stairs connecting the levels may be inside the building (parallel to the longitudinal axis) or outside of it over the façade, built in steel or reinforced concrete (See Picture 4). The roofing mostly consists of metal sheathing (usually zinc) over metallic beams (I-shaped or rectangular) which make it very light; however, the roofs are not well bonded to the surrounding support elements (columns and walls) (See Picture 5). Roofs are heterogeneous, with rather peculiar solutions. Water dripping is frequent. The weight of the light roof is considered as  $0.4 \text{ kN/m}^2$ .

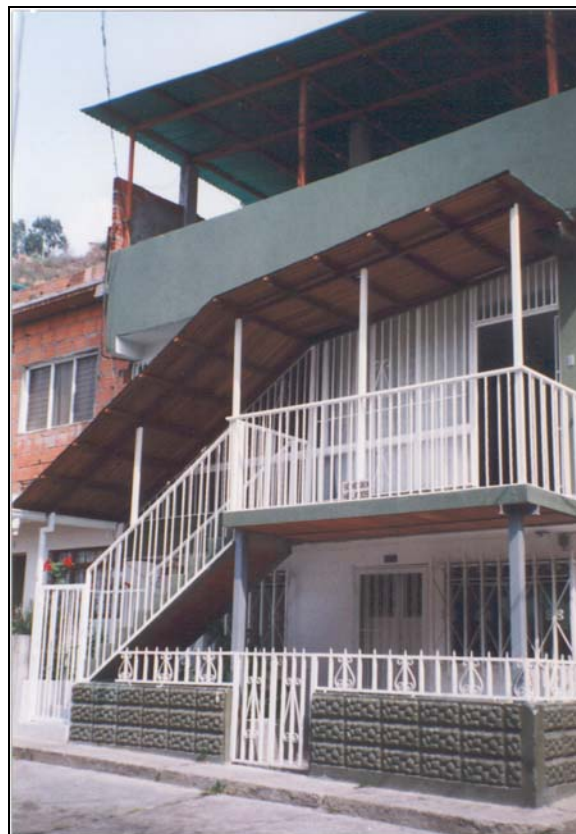
**Picture 4: Stair in the front of a building.**

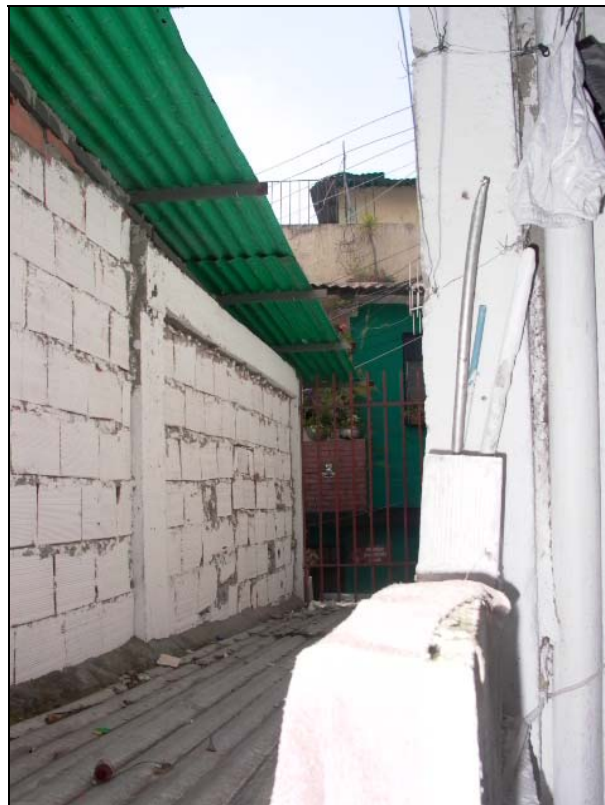
**Picture 5: Metallic sheathing roofing. Poor bonding to frame and walls.**

The general level of quality, yet rather poor, is better than expected (taking into account the adverse conditions). The construction quality of many elements in the dwellings is not adequate; the self-constructed and phased feature does not allow quality control for the materials and their assemblage. For example, many broken masonry units and discontinuities are observed in the walls, the bonding mortar does not resist scratching, the running of the blocks are not horizontally aligned, the light roofs are not properly tied, there are shrinkage cracks in floors, and there are cavities and erosions in the frame members, with observed irregularities due to framework positioning. Reinforcement cover is not enough (even some of the bars are visible). In some cases soil erosion surrounding the foundations is observed in steep sites.

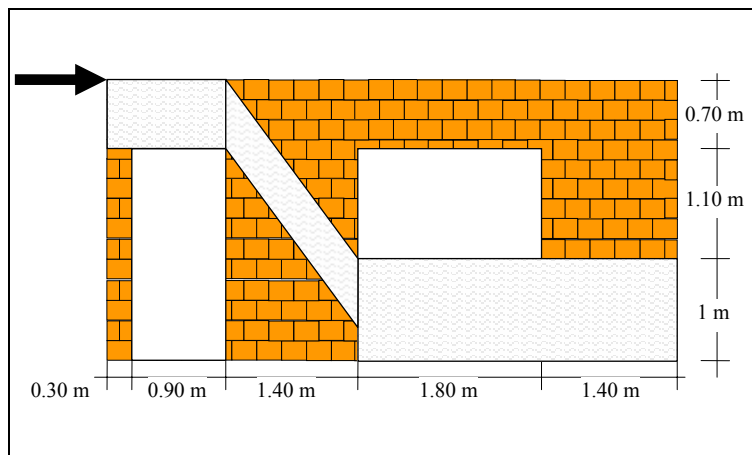
Figure 6.19 and Figure 6.20 present possible failure mechanisms for a cladding wall pushed by lateral forces. It is remarkable that the percentage of openings has been conservatively assumed as significantly bigger than the 30% considered in the estimation of the shear strength.

**Figure 6.19: Failure mechanism for cladding wall and left force.**

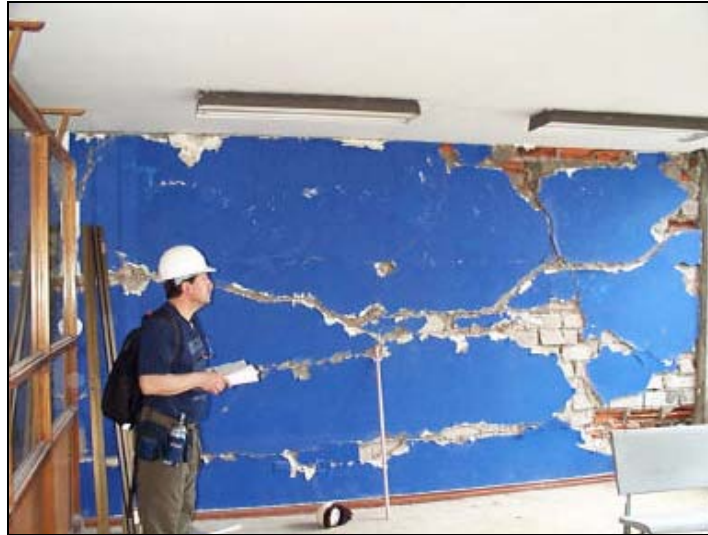
**Picture 6: Damage in masonry wall (3<sup>rd</sup> floor), building in Pereira, Colombia [Pujol et. al, 1999].**

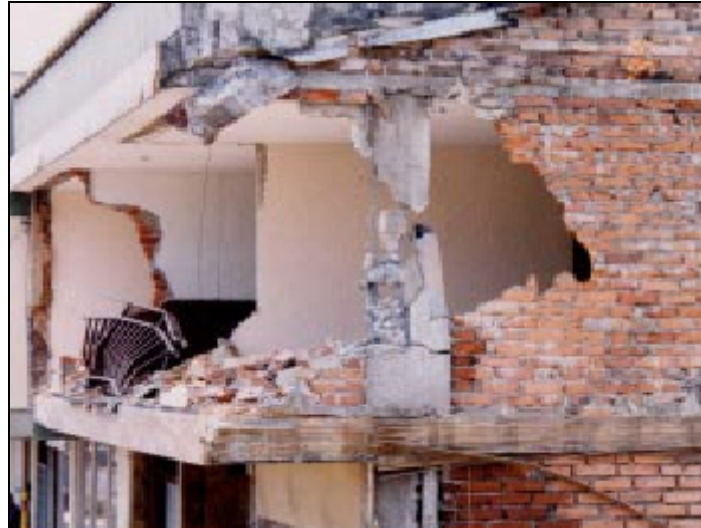
**Picture 7: Damage to a RC a column, building in Armenia, Colombia [Yoshimura et. al, 1999].**

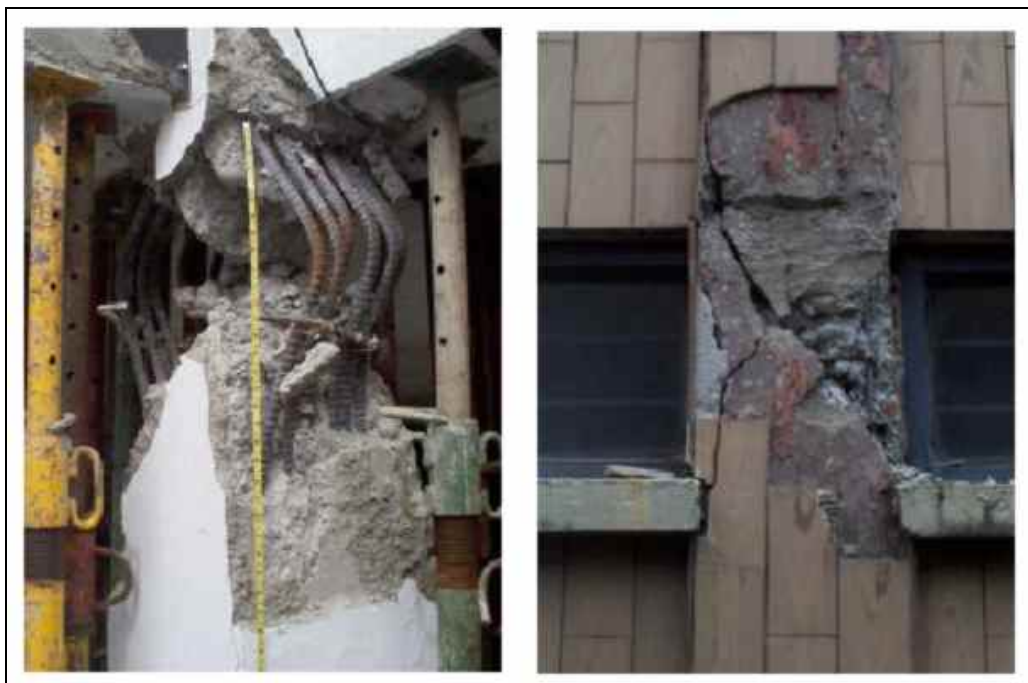
**Picture 8: Damage in columns. Left: buckling of longitudinal reinforcement due to the lack of adequate transverse reinforcement. Right: Short-column effect. Both buildings in Armenia, Colombia. After [Pujol et. al, 1999].**

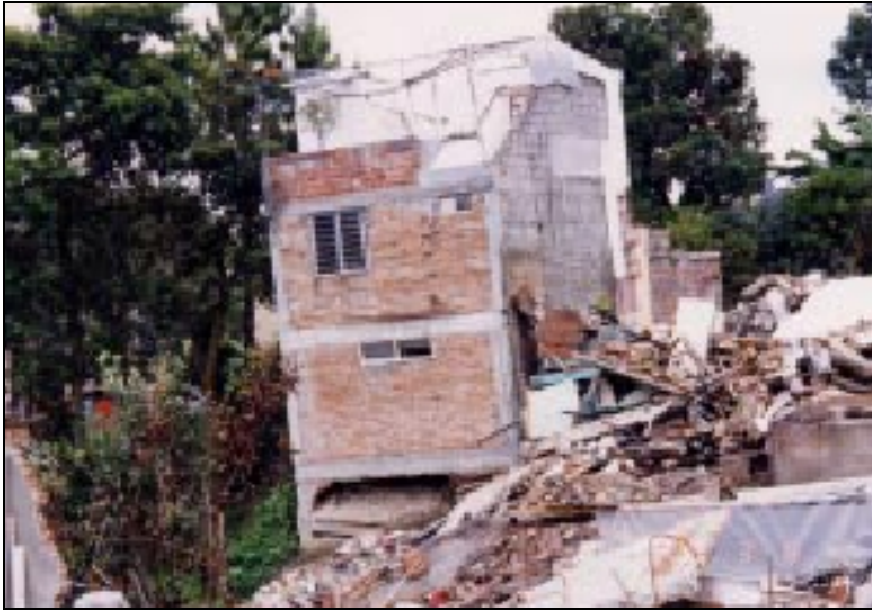
**Picture 9: Damage in building due to steeped soft soil. Building in Armenia, Colombia. [Yoshimura et. al, 1999].**

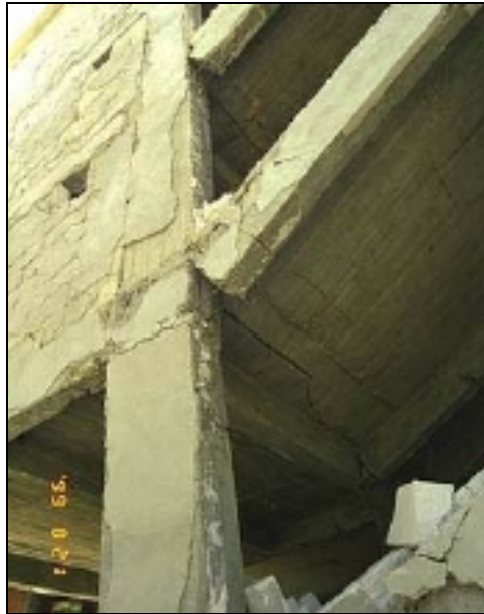
**Picture 10: Beam damage, longitudinal reinforcement slippage. Building in Adapazari, Turkey [PEER, 2000].**

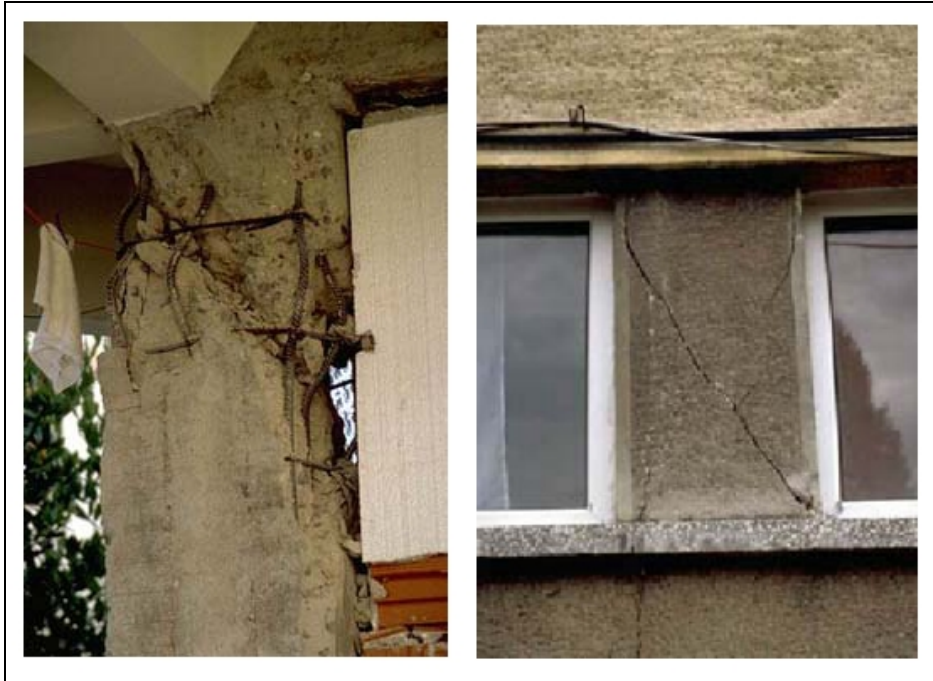
**Picture 11: Damage in columns. Left: Shear and axial failure due to excessive stirrup spacing. Right: shear failure in captive column. Building in Adapazari, Turkey [PEER, 2000].**

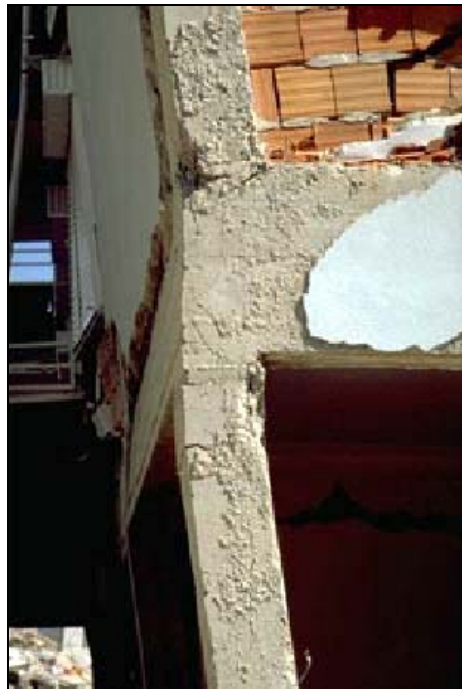
**Picture 12: Damage to beam-column joint, large rotations at the end of the columns. Building in Adapazari, Turkey [PEER, 2000].**

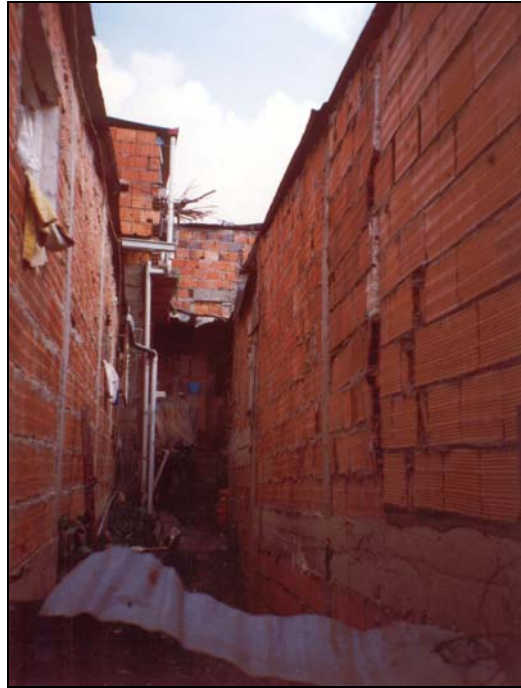
**Picture 14: Alley in the Cristo Rey Sector showing four houses, the low quality of workmanship and materials in the walls and the absence of collar beams is observed.**

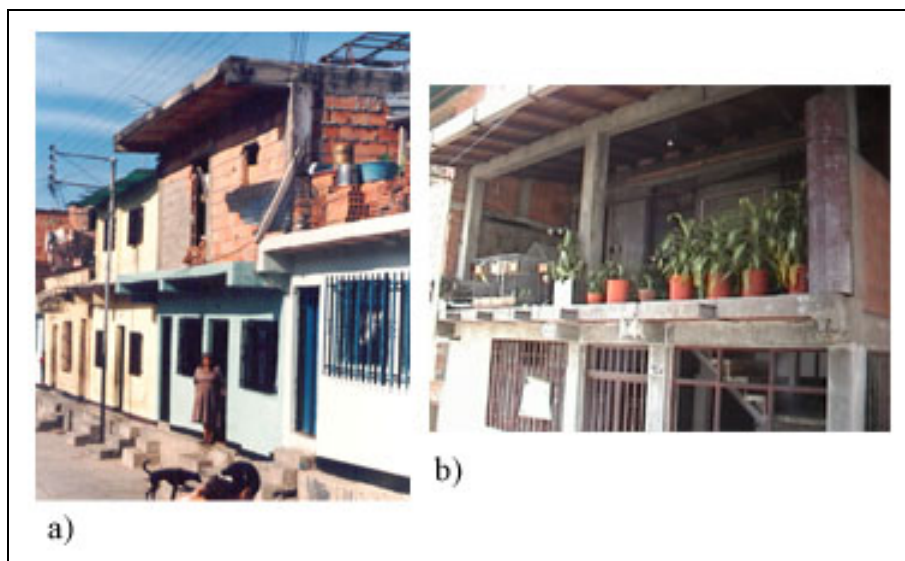
**Picture 16: Roof Types in Barrios. a) Slab roof in one or more levels, and metal sheeting roof in two levels. b) Tile roofing supported over wooden deck and “I” shaped steel beams.**

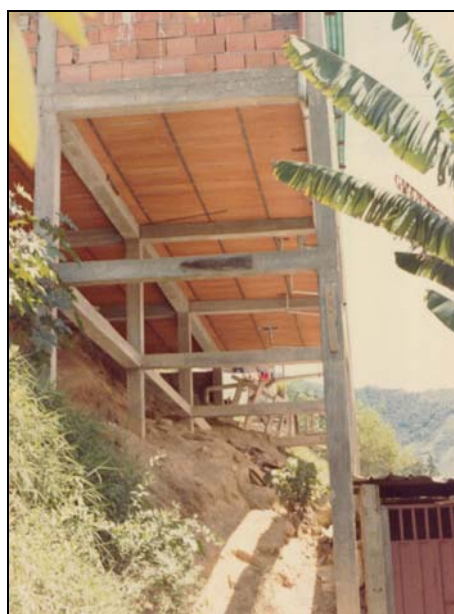
**Picture 17: High-slope site for housing unit, structural members are observed in different lengths, with low-ductility elements in the middle structural axis, see columns over the foundations.**

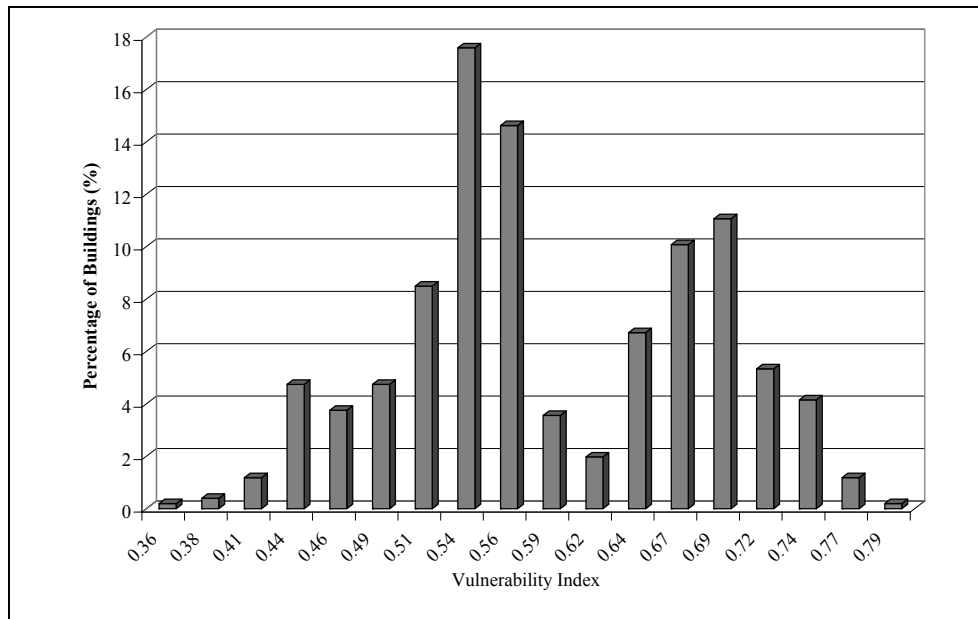
**Figure 6.29: New vulnerability index distribution considering the adjacency parameter.**

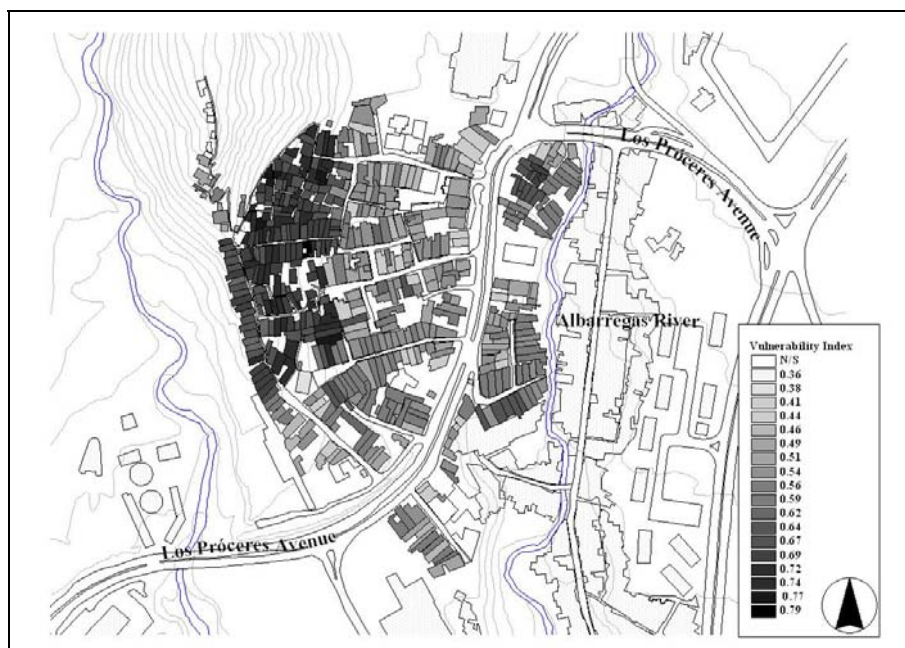
**Map 6.14: New vulnerability index distribution in La Milagrosa Barrio, considering the adjacency parameter (N/S: Not studied).**

The distribution of the indices in the Barrio is shown in Figure 6.29, where the categories are now 18 instead of the 12 without considering the adjacency parameter. The result of including this parameter is more resolution in the vulnerability indices, as it may be seen in Map 6.14, where the highest indexes concentrate where adjacency problems are expected to be most probable.

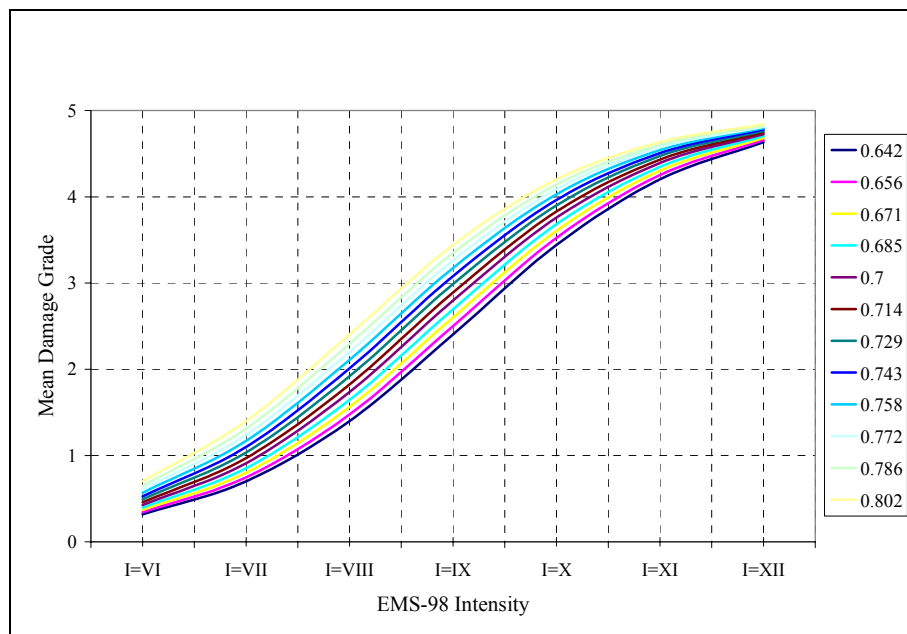
Figure 6.30: Mean semi-empirical vulnerability functions for LM1 classification.
