Contributions to the Development of Cured-in-Place Pipe Composite Liners for Pressure Water Pipes Rehabilitation

Ferran Gras Travesset

DOCTORAL THESIS

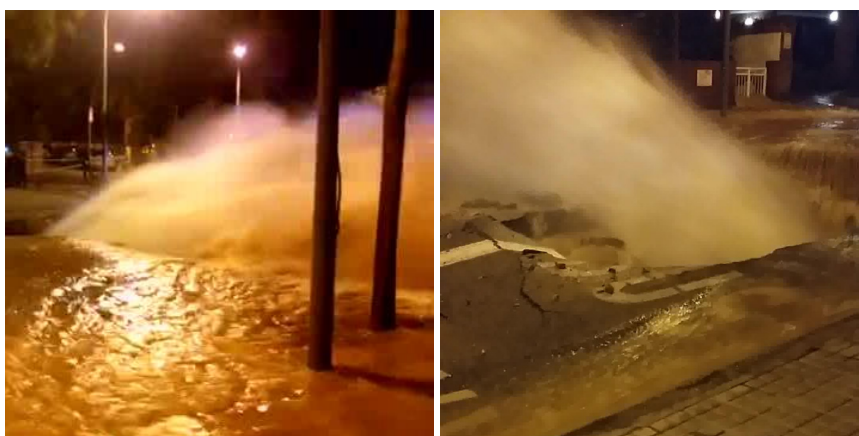
Figure 1.1: Example of real pressure pipe failure causing important damage to the road and third parties.

A vast pipeline network is responsible of providing drinking water to most world's population. In most developed countries, the pipeline was built between 1920 and 1970. The life expectancy of pipes depend on the materials and manufacturing techniques. In concrete pipes it can be set around fifty years. During this period, regular inspections must be performed to check the degree of deterioration of the pipe due to aging. Some times, a small reparation can extend the life of a whole pipe section. Nevertheless, a completely renovation may be needed in the case of advanced states of deterioration or severe damage. Otherwise, constant leaks and failures may often occur even in the same section of the pipeline. Some of these leaks on buried pipes are difficult to detect when no third parties are affected. However, a pressure pipe failure can led to catastrophic consequences as shown in Figure 1.1.

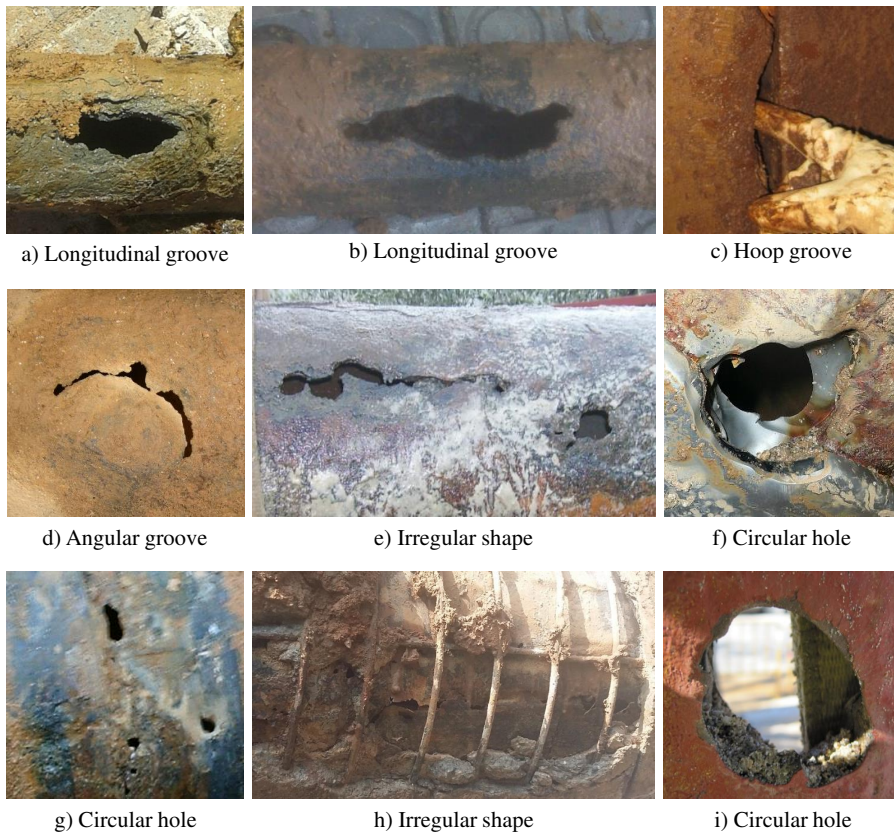
Figure 2.19: Holes typology reported in real host pipes. Circular-like holes (f-g, i), longitudinal grooves (a-b), hoop grooves (c), angular grooves (d) and completely irregular shapes (e, h).

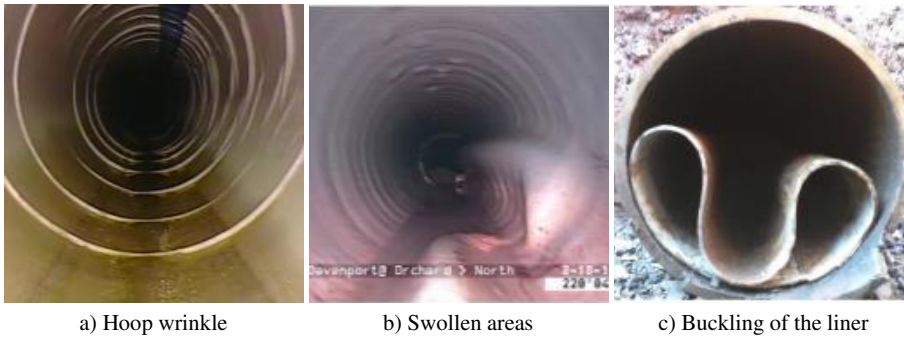
Figure 3.2: Defects caused by difficulties in the installation of the liner: hoop wrinkles (a), swollen areas [94] (b), and the buckling of the liner [94] (c).

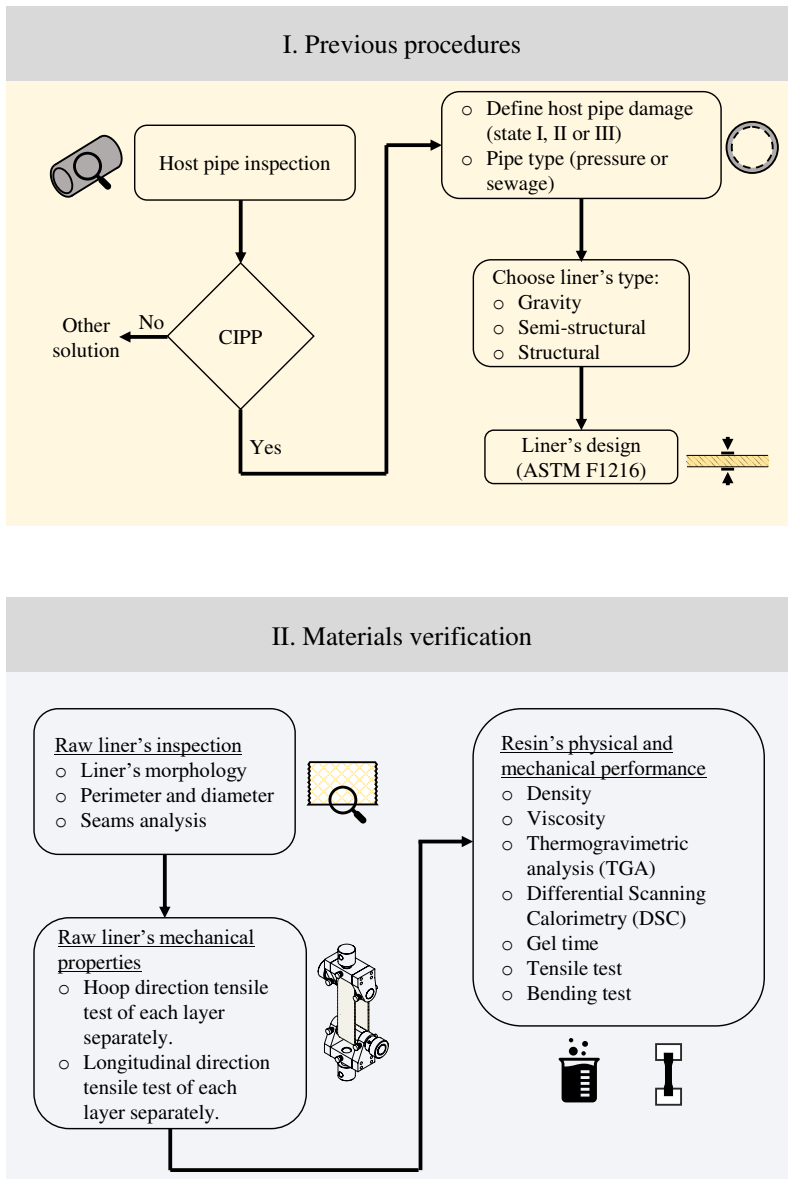
Figure 3.5: Schematic representation of the proposed quality control protocol - Part 1.

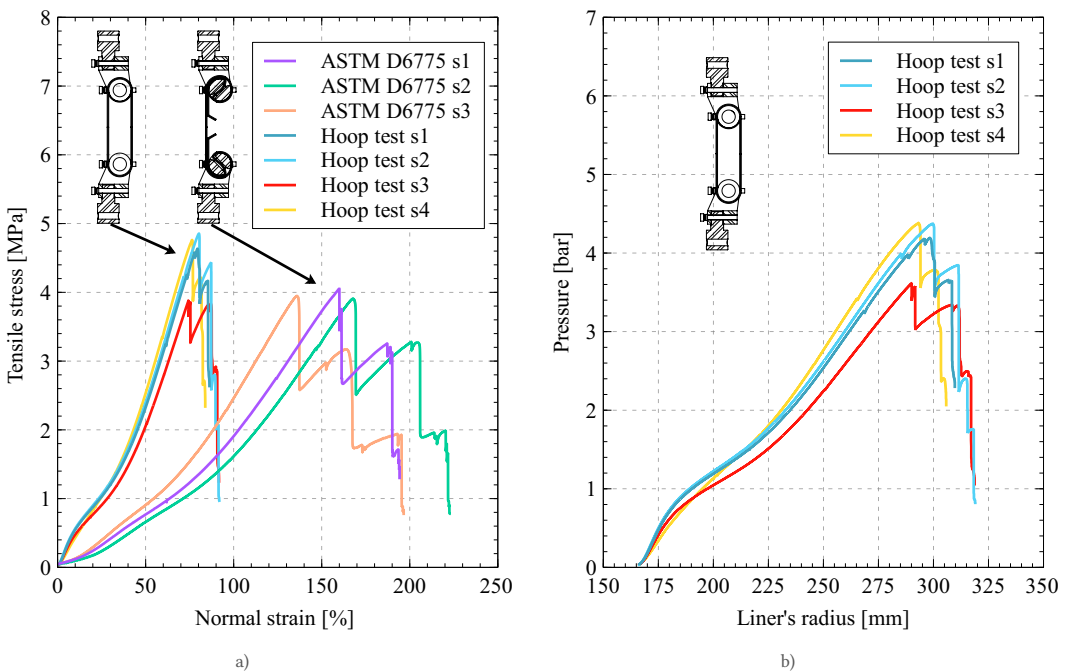
Figure 3.10: Assessment of the tensile properties of the raw liner. Hoop test and ASTM D6775 [96] comparison (a). Required installation pressure deduced from the hoop test (b).

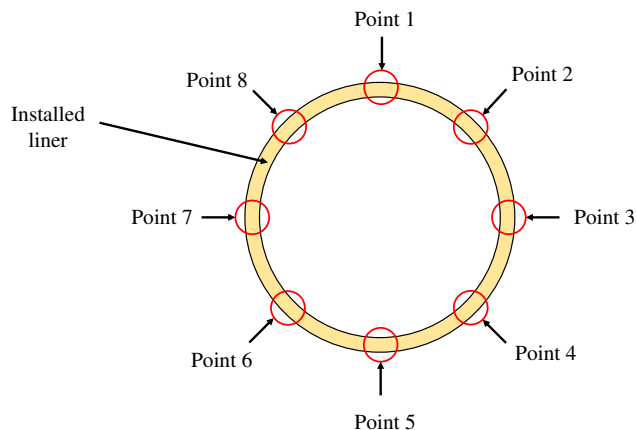
Figure 3.14: Equally spaced measurement points to evaluate the thickness of an installed liner.

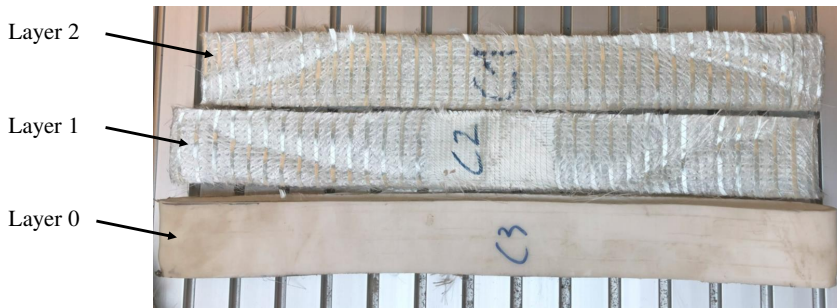
- **Layer 0:** this layer is made of a PP coating attached to a thin felt.
- **Layer 1:** this layer comprises a mesh of multidirectional glass fibers onto a polyester sheet. In addition, longitudinal bundles made of glass fiber are identified.
- **Layer 2:** this layer is identically distributed as layer 1.

Figure 3.15: Raw liner composition analyzed in the materials verification stage.

The materials verification stage was evaluated with a semi-structural liner made of three main layers containing seams (see Figure 3.15). A resin certified to impregnate this liner was also assessed.

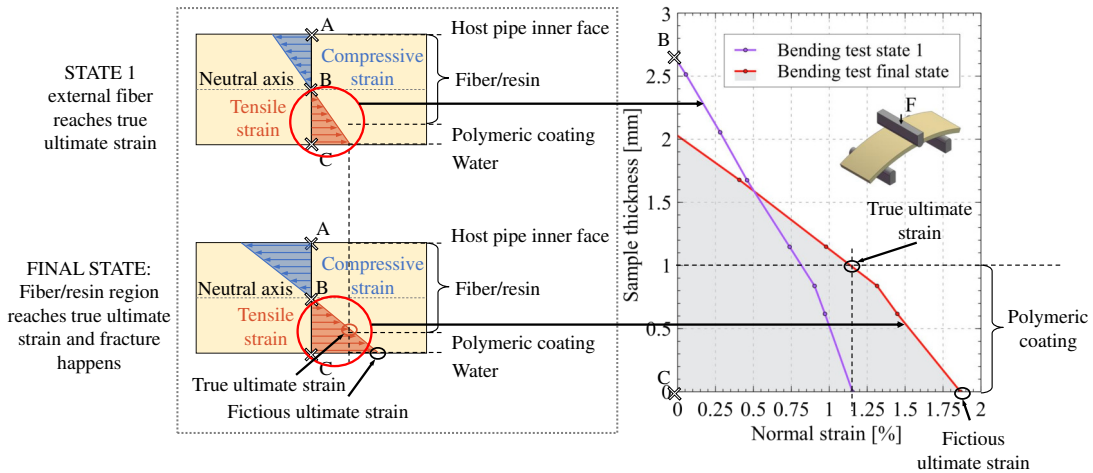
Figure 4.29: Strain distribution of a sample tested by the three-point bending test of curved samples captured an instant before failure occurred. Measurements made with experimental digital image correlation.

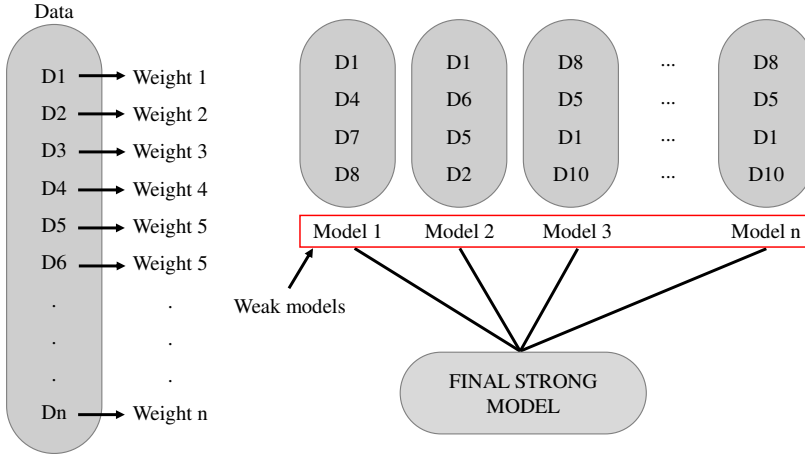
Figure 5.2: Scheme representing the architecture of the mathematical model.

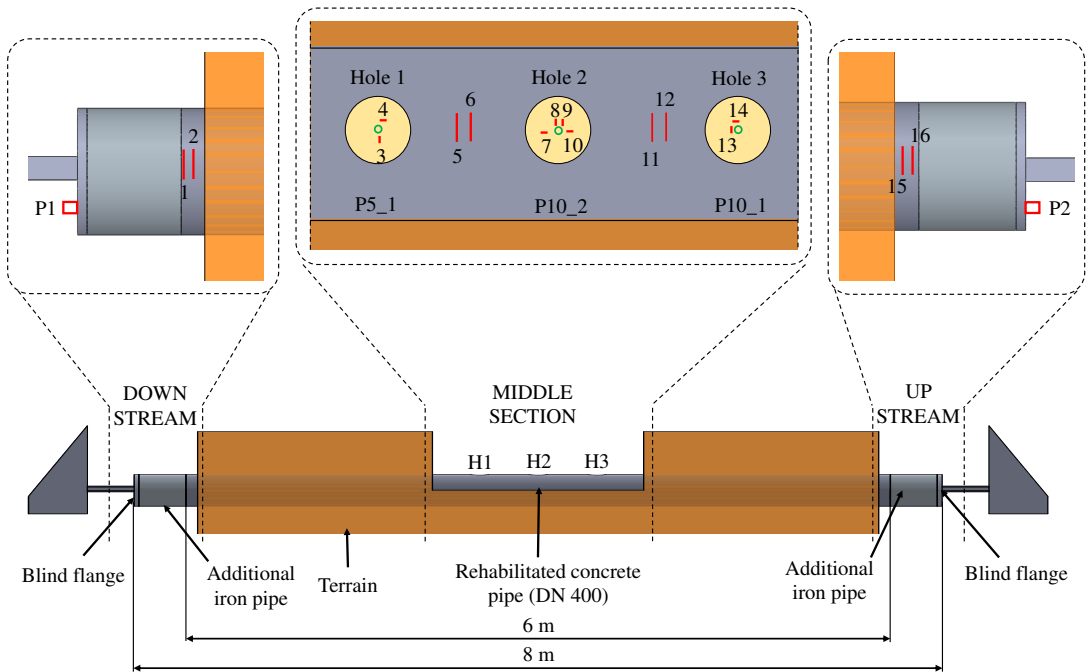
Figure 5.3: Schematic representation of the full-scale test setup showing the location of sensors and components employed in the test.

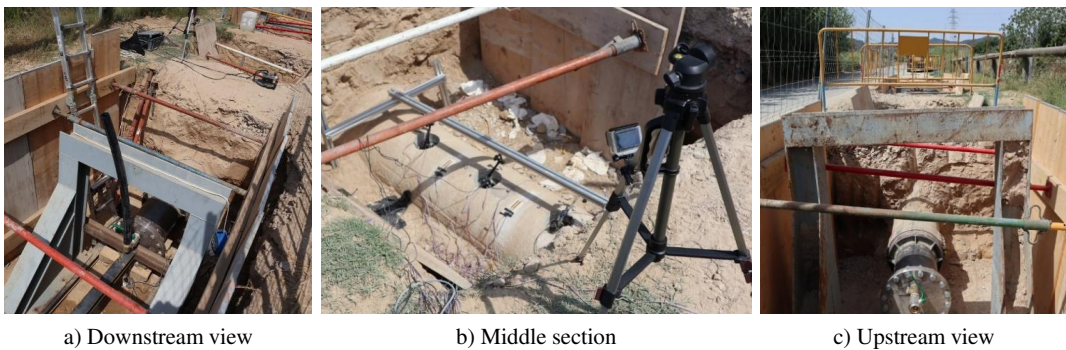
a) Downstream view

b) Middle section

Liner one described in section 5.3.1 was used to rehabilitate 6 m of the buried reinforced concrete pressure pipe of DN 400 mm. In addition, one extra meter of cast iron pipe was added at both ends to fit both blind flanges with the ends of the reinforced concrete pipe. Therefore, eight meters of liner were installed. The setup test was divided into three monitoring sections: downstream, middle section, and upstream (see Figure 5.3 and Figure 5.4)

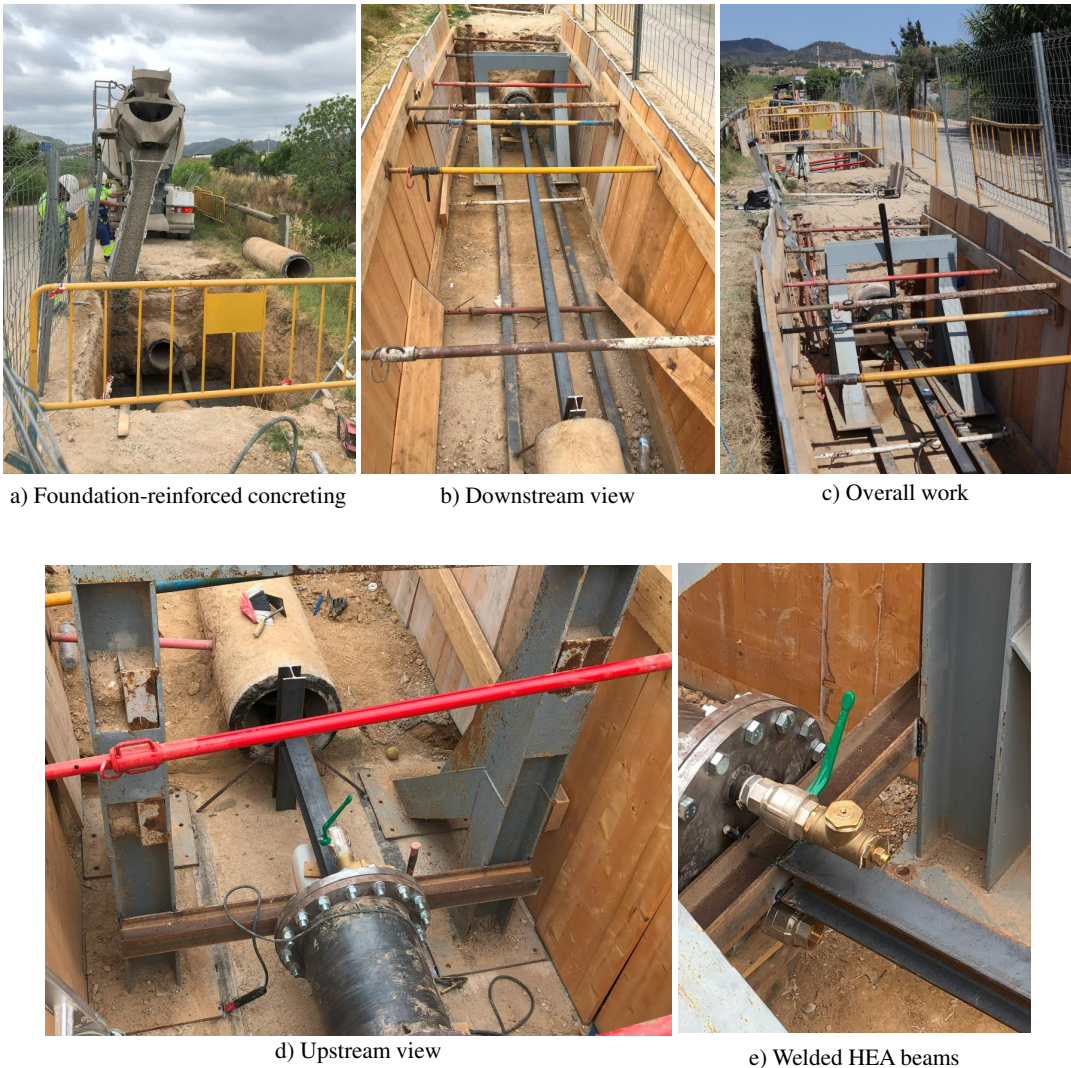
Figure 5.7: Detailed setup for fixing the blind flanges to withstand 25 bar in a DN 400 mm pipe: foundation-reinforced concreting (a), detail of the downstream view (b), general view of the work (c), detail of the upstream view (d), and detail view of the welded HEA beams (e).

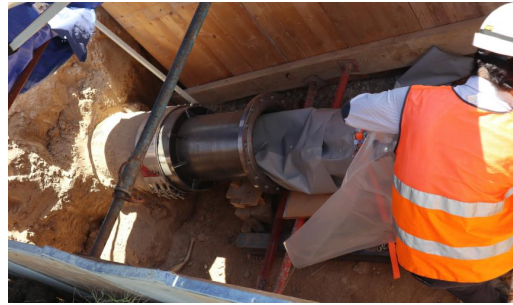
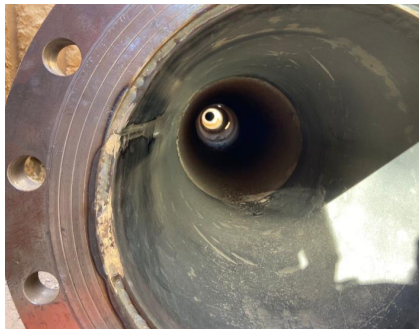
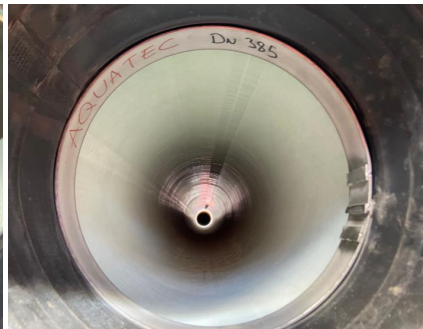
a) Liner introduction

b) Inside view before the rehabilitation

c) Inside view after the rehabilitation

Figure 5.8: Installation of the CIPP UV liner: introduction of 8 m of liner (a), inside view of the reinforced concrete host pipe with the additional iron pipe before the installation of the liner (b) and inside view after the rehabilitation (c).

On the other hand, a setup of HEA beams and railway ends was built up to fix the host pipe endings (see Figure 5.7). The setup was designed to withstand more than 25 bar in a DN 400 with a robust safety factor. The HEA beams were welded to the railway ends. Then, each railway end was fixed to its respective reinforced concrete foundation (see Figure 5.7a) of the upstream and downstream sections. A close look at the setup is shown in Figures 5.7d-e. Then, the liner was installed (see Figure 5.8a). A close look at the inside of the rehabilitated host pipe before and after the installation of the liner is shown in Figure 5.8b-c. Finally, current commercial seals were installed.

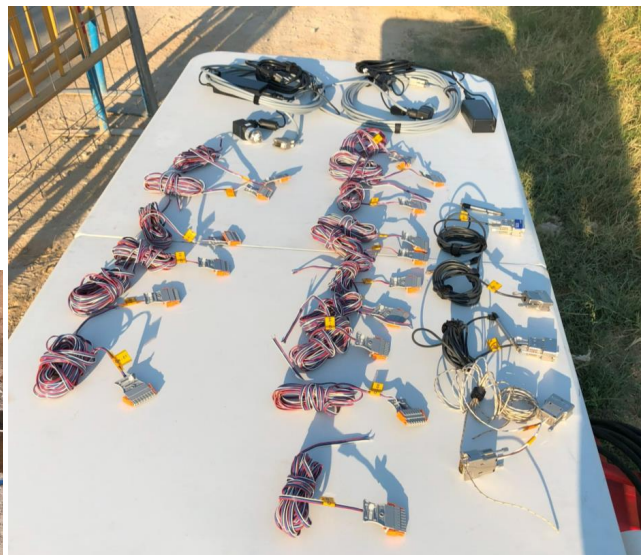
b) Deployment of all sensors used

Figure 5.9: Sensors installed to monitor the host pipe and the installed CIPP liner. Detailed view of the upstream pressure sensor location (a) and deployment of all sensors used: strain gauges, displacement, and pressure sensors (b).

The rehabilitated host pipe was monitored with 16 strain gauges, three displacement transducers, and two pressure sensors (see Figure 5.9b). Eight strain gauges were installed directly onto the liner through the pipe holes. Strain gauges 3, 8, 9, and 13 were installed in the hoop direction, and strain gauges 4, 7, 10, and 14 were installed in the longitudinal direction. In addition, strain gauges 1, 2, 5, 6, 11, 12, 15, and 16 were installed on the reinforced concrete pipe in the hoop direction to monitor the host pipe according to the installation procedure shown in Figure 5.10. Three displacement transducers were held in the center of each hole. Two temperature sensors were also set to calibrate the strain gauges.

Finally, two pressure sensors, Wika A-10, were installed at the lowest part of the ends of the pipe (see Figure 5.9a). HBM Quantum X MX840 B, Quantum X MX1615 B, and CatmanEasy AP software collected data from the full-scale test (Figure 5.11). Finally, a 40 bar Rothenberger RP Pro III pump was used to feed the test with hydraulic pressure until 25 bar. A scheme of the setup of the test is shown in Figure 5.3.

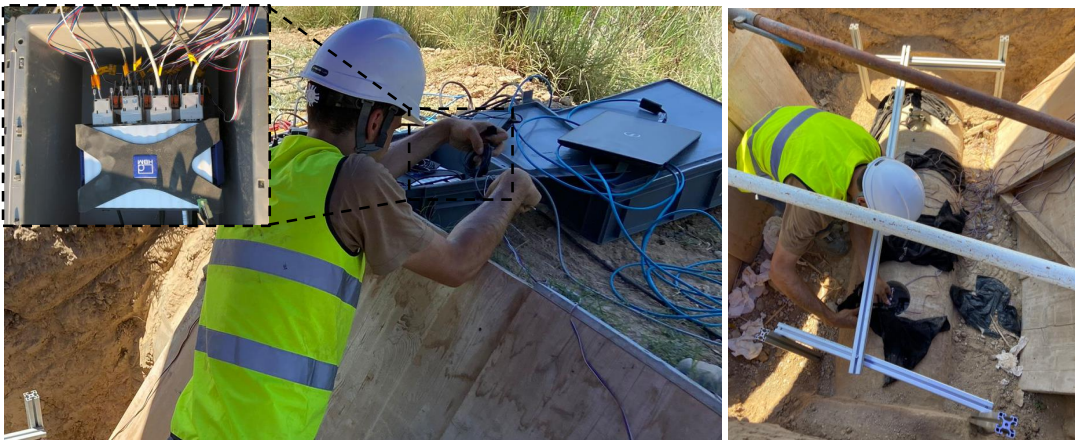
Figure 5.11: Installation of the middle section liner's strain gauges under challenging field conditions (July, Barcelona).

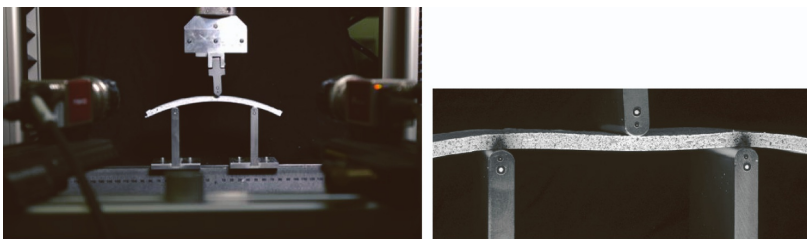
Fig. 10. Digital Image Correlation setup used during the three-point bending test of curved samples.

A 3D Digital Image Correlation (DIC) system was used during the three-point bending tests to analyze the strain distribution along the thickness of the CIPP samples. To create the speckle pattern, the samples were airbrushed with different tip diameters (see Fig. 10). Two Allied Vision GigE MAKO G-507B GigE cameras with APO-Xenoplan 1.4/23-0903 objectives were used to record the surface displacement of the samples. Calibration was performed with a GOM CP20/MV55×44 panel with an offset of 0.021 pixels. The measurement volume resulting from the calibration was $150 \times 130 \times 110$ mm. Finally, the image sequences were post-processed with GOM Correlate Professional software using a facet size of 12×12 pixels.

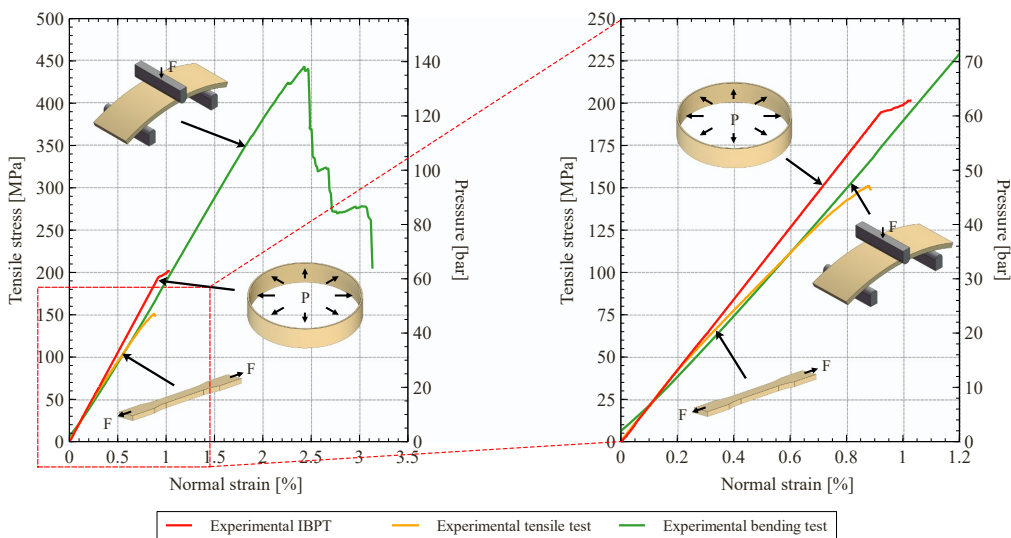
Fig. 22. Comparison between tensile, bending and IBPT of CIPP composite tests results.

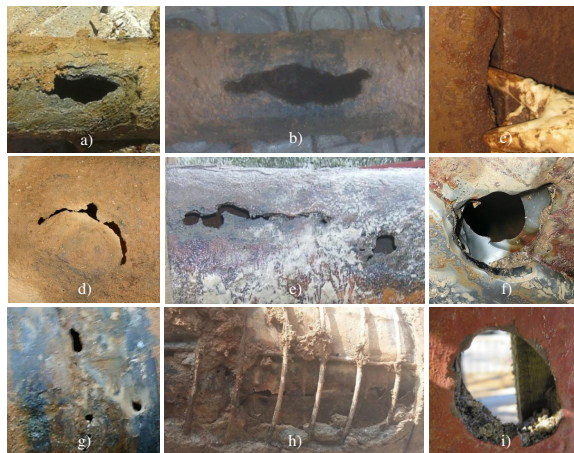
Figure 1: Examples of holes detected in damaged pipes.

According to UNE 53929 (2022) and ASTM F1216 (2022) guidelines. Then, the circular shape was gradually distorted, progressing to elliptical holes and eventually linear grooves. Finally, the linear grooves were deformed to obtain more complex shapes, such as angular grooves (fig. 7). It is worth noting that these four simulated hole types were inspired by real pipe holes (fig. 1).
